Manhole Inspection Summary

Manhole # S19Y__013MH

Insp Date: **6/3/08 10:10 AM**

Location Address: **2435 grinnalds av**

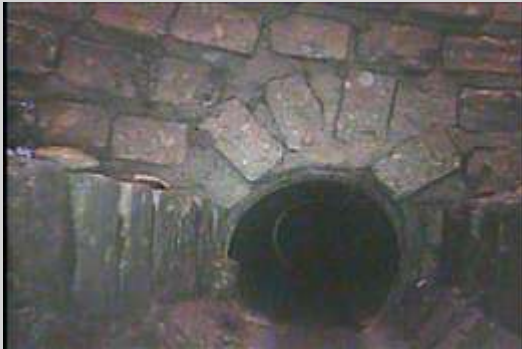
12 O'Clock Outflow

Pipe Height: **8.4** (in.) Rod and Bar (Angled)
Pipe Material: **Clay** ☐ Pipe Lined
Invert Depth: **9.35** (ft.) Flow Characteristics: **Slow**
Deposits: ☒ None ☐ Mud ☐ Sludge ☐ Debris ☐ Grease
Silt Depth: **0** (in.) Deposits Extent:
Infiltration: **None** Pipe Seal Cond: **Sound**

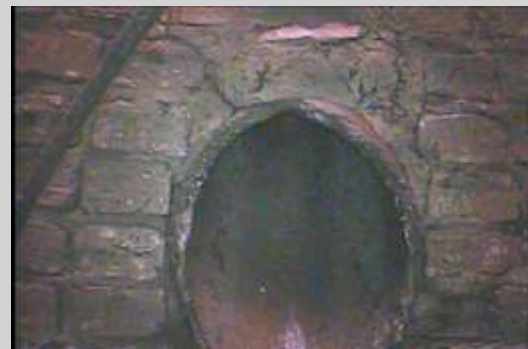
Drop In @ 3 O'Clock

Drop: **Outside** Rod and Bar
Angled: **Yes** Reading: **7.42** (ft.)
Inv Depth: **8.42** (ft.)
Drop Condition: **Open**

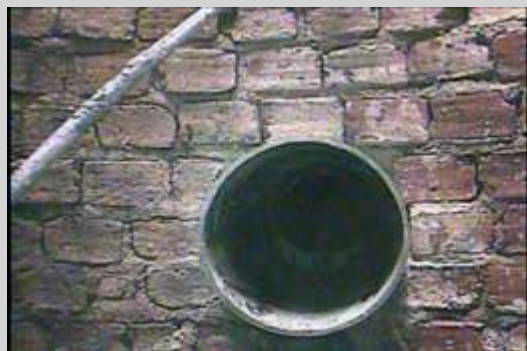
6 O'Clock Inflow

Infiltration: **None** Pipe Seal Cond: **Sound**

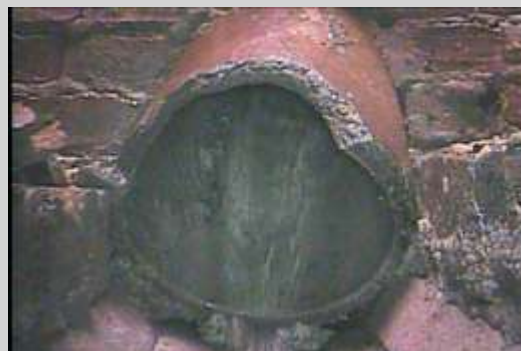
Drop In @ 6 OClock

Drop: Outside	Rod and Bar
Angled: Yes	Reading: 7.80 (ft.)
	Inv Depth: 8.80 (ft.)
Drop Condition: Open
